Manhole Inspection Summary

Manhole # S19II2003MH

Insp Date: **4/24/07 10:15 AM**

Location Address: **5928 FALLS RD** Cross Street: **WASHINGTONVILLE DR**

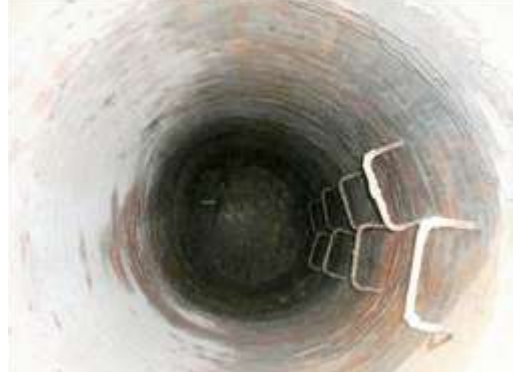
Top View

Corroded steps. Channel debris.

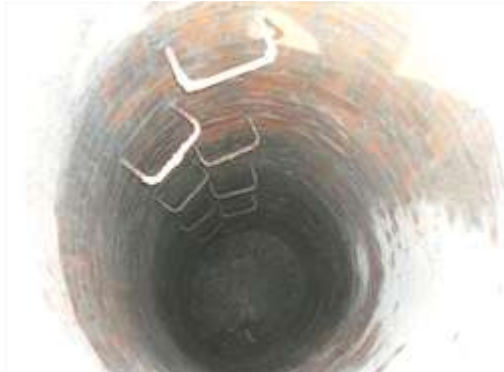
Defect

Frame leaks. Adjustment, Corbel, and Barrel infiltration.

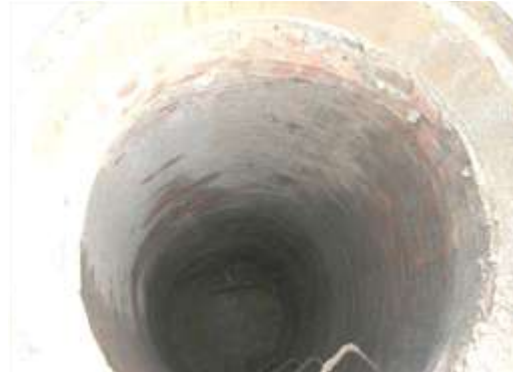
Defect

Frame leaks. Adjustment deterioration. Adjustment, Corbel, and Barrel infiltration - other side.

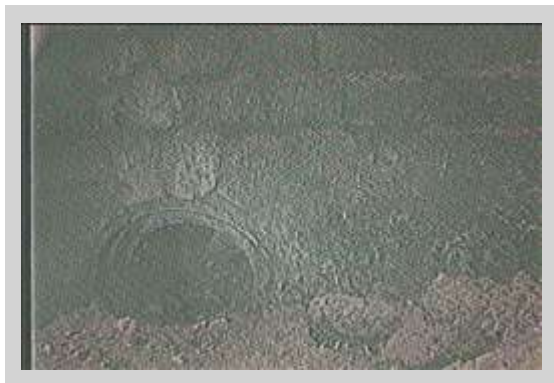
Pipe Out @ 12 O'Clock

Comments **The O12 pipe picture shows Barrel deterioration.**

Deposits: ☐ None ☐ Mud ☐ Sludge ☒ **Debris** ☐ Grease

Infiltration: **Evidence**
